## Case Study 0313

Shallow Vertical Gas Well Cleanout Activities in NE  
Alberta Canada

**Version 1.3** May 12, 2011

**Presented by:** ADL Oilfield Services

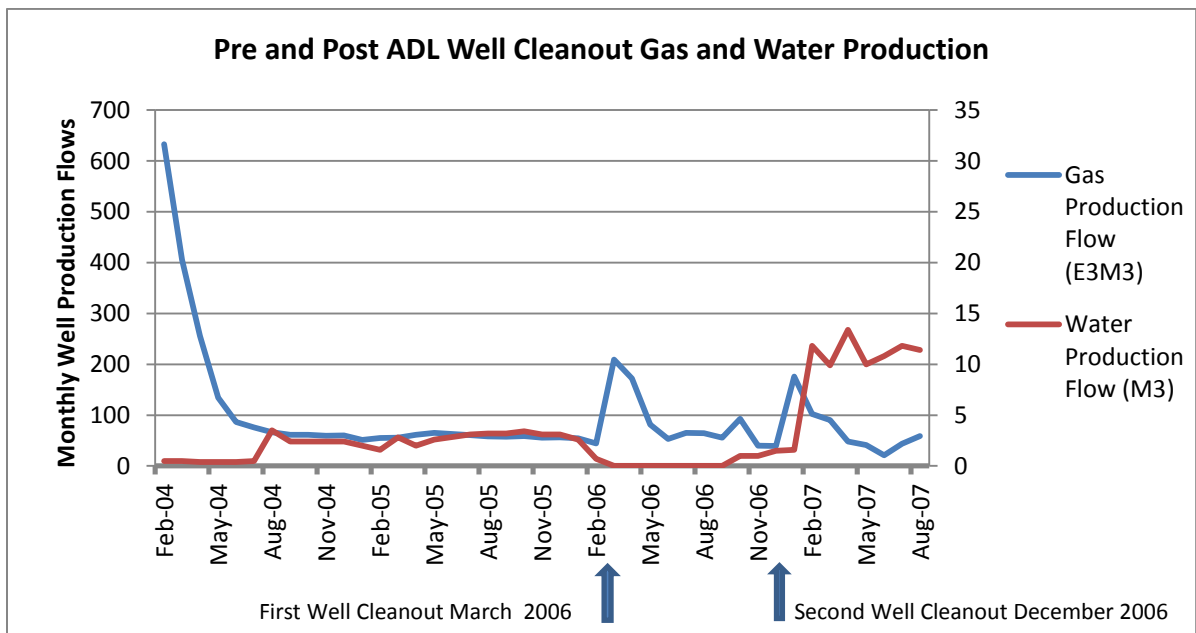
The following graph depicts well gas production before and after the ADL Stable Foam cleanout:

ADL Stable Foam extracted a total of approximately 1.50m<sup>3</sup>, or 396 gallons of heavy bitumen. Based on examination of debris contents and the volume of bitumen extracted, it was concluded bitumen accumulation was the primary cause of gas volume decline.

The Stable Foam application process required 7 project hours to assess, stage, execute and complete, including a 90 minute chemical soak. The well data shows increased post cleanout gas production with sustained gas production spanning 10 months. Post cleanout monitoring by ADL staff encouraged the well operator to not over produce the well, resulting in less stress to the formation and sustained production.

A second ADL cleanout application was requested and provided in December of 2006. Similar increases in gas production were achieved, further extending the productive life of the well. The above graph clearly shows increased water production, preventing the well from stable gas production. The ADL consulting team recommended a capillary soap injection, or siphon string application in an effort to control water predominance and improve gas production.
